**RE: Savory Elementary Pedestrian Bridge  
Structural Assessment Report**

**RJC No. VIC.143561.0001**

Project Name  
**Savory Elementary School - Pedestrian Bridge**

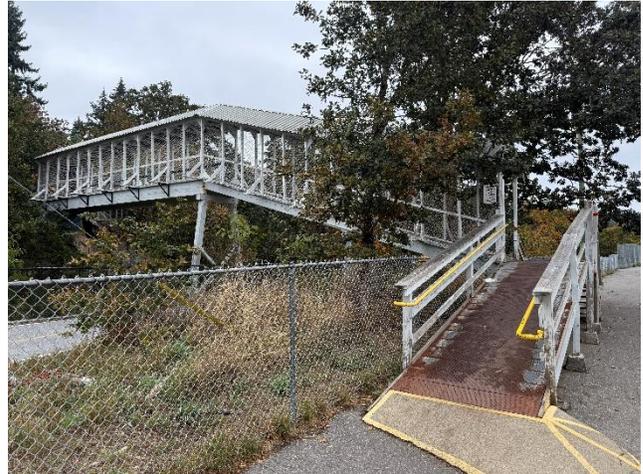
Figure 1 – Pedestrian Bridge at Savory Elementary

The pedestrian bridge at the Savory Elementary is a predominantly wood frame bridge that spans over the E&N trail and rail line to Atkins Road. The footprint is approximately 1.5m by 32.6m, with a dogleg at the north end. The majority of the span has a roof over the walking surface which is metal roofing material over conventional 2x4 sawn lumber. The spans are supported by a mixture of concrete buttress walls or heavy timber frames supported on concrete bases.

Record drawings are unavailable, and the original construction date is unknown; however, from our staff's memory, the bridge has been in place for several decades. It appears like there have been some renovations, including the addition of the roof over the walkway, modification of the guards on either side, and possible revisions to the access on the Savory Elementary property. Our understanding of the structure is entirely based on what we could observe and measure on site.

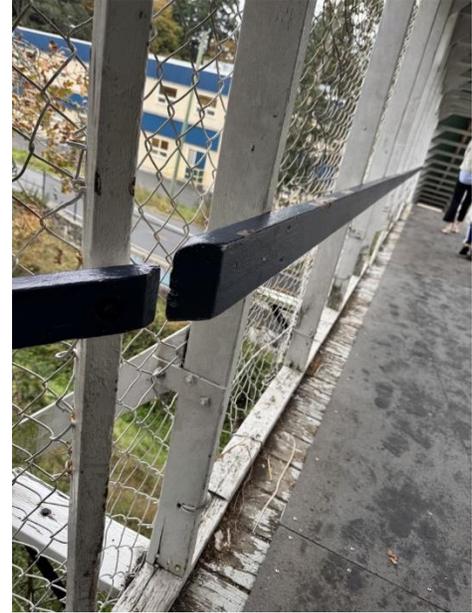
Figure 2 – Typical Guard System

For the primary structure, the most significant concern is with the guard and picket system for the walkway. The continuous 2x4 is not a suitable top rail; the 2x4 at 610 studs has insufficient strength and is not sufficiently restrained at the top, and the chainlink does not meet code requirements for pickets. Even with the exterior bracing at 1220 o.c. in some spans, it is not believed the enclosure could resist the prescribed loading from the building code for a guard rail, indicating a falling hazard within the primary walking path.

- Remove and replace deteriorated 2x6 boards
- Remove the superstructure and re-frame with 6x6 posts, a 4x4 top rail, and code complaint pickets
- Re-frame a new roof with a plywood diaphragm. This could be trusses or site-built framing

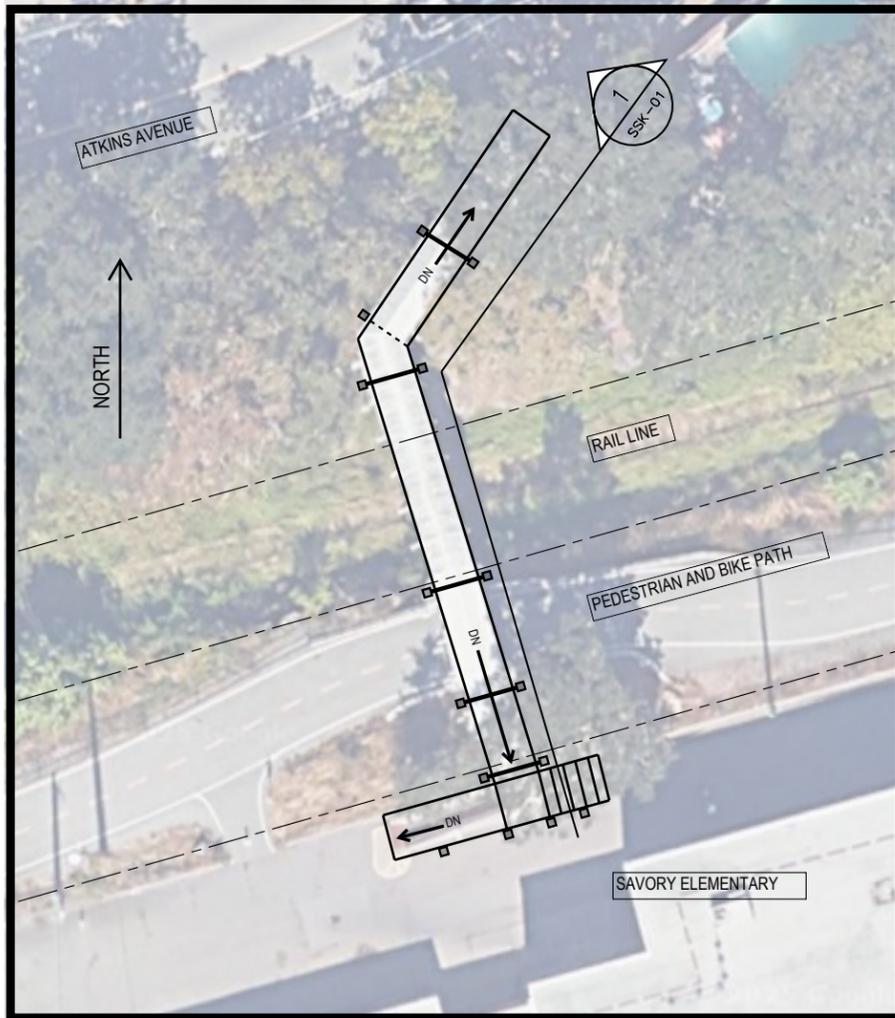
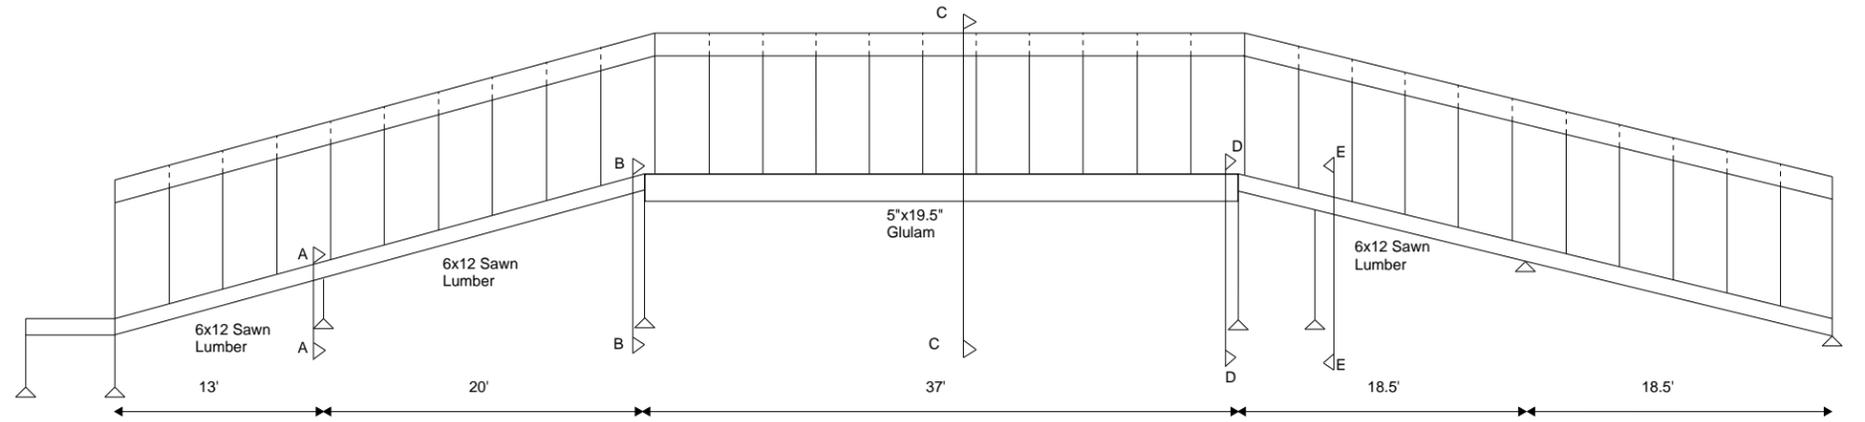
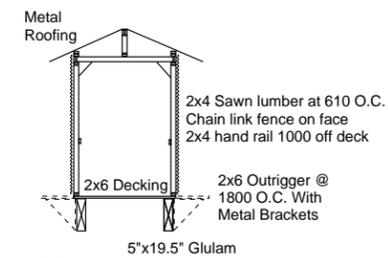
Sketch Title  
**Existing Conditions**

1. UPGRADE THE SUPER STRUCTURE OF THE PRIMARY SPAN TO BE A FULLY CODE COMPLIANT GUARD RAIL SYSTEM.
2. REMEDIATE DETERIORATED ELEMENTS, PRIMARILY THE DECKING OF THE MAIN SPAN.
3. IMPROVE THE OVER SEISMIC SAFETY OF THE STRUCTURE.

NOT A STRUCTURAL CONCERN THE BRIDGE APPEARS TO HAVE ISSUES WITH ACCESSIBILITY WITH THE STEEP ANGLE OF SOME OF THE RAMPS. CODE COMPLIANCE REVIEW BY AN ARCHITECT IS RECOMMENDED.

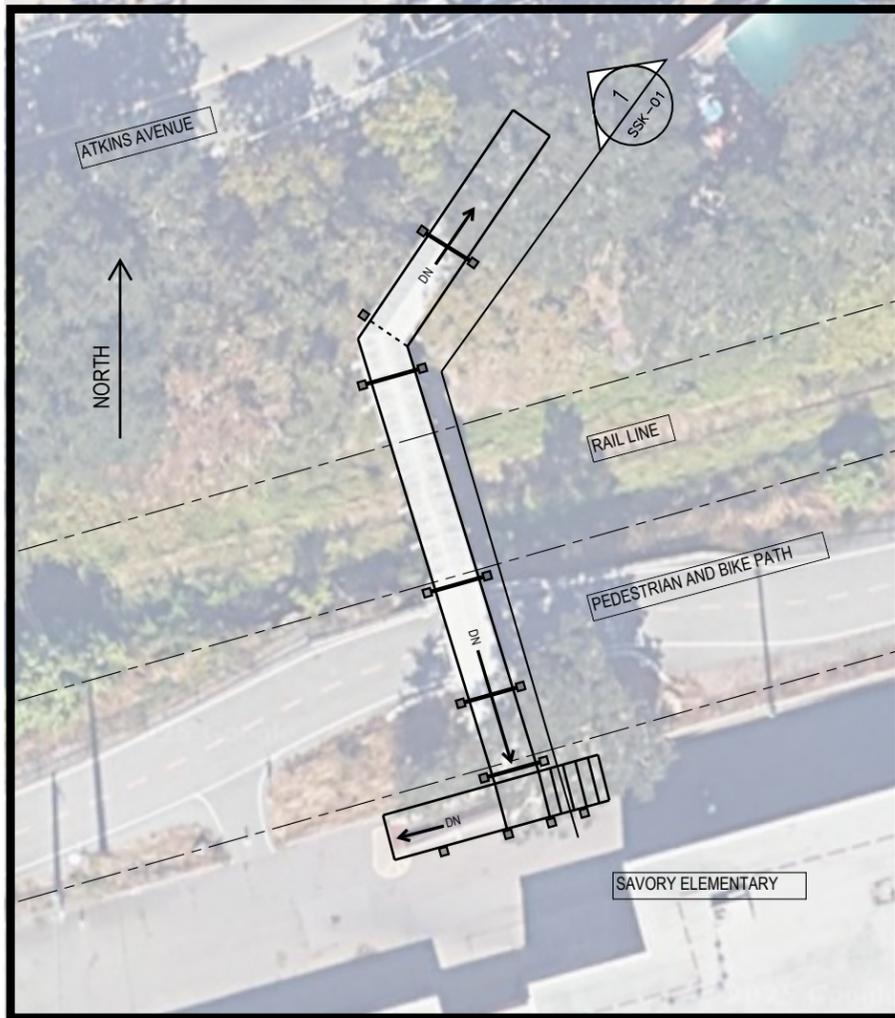
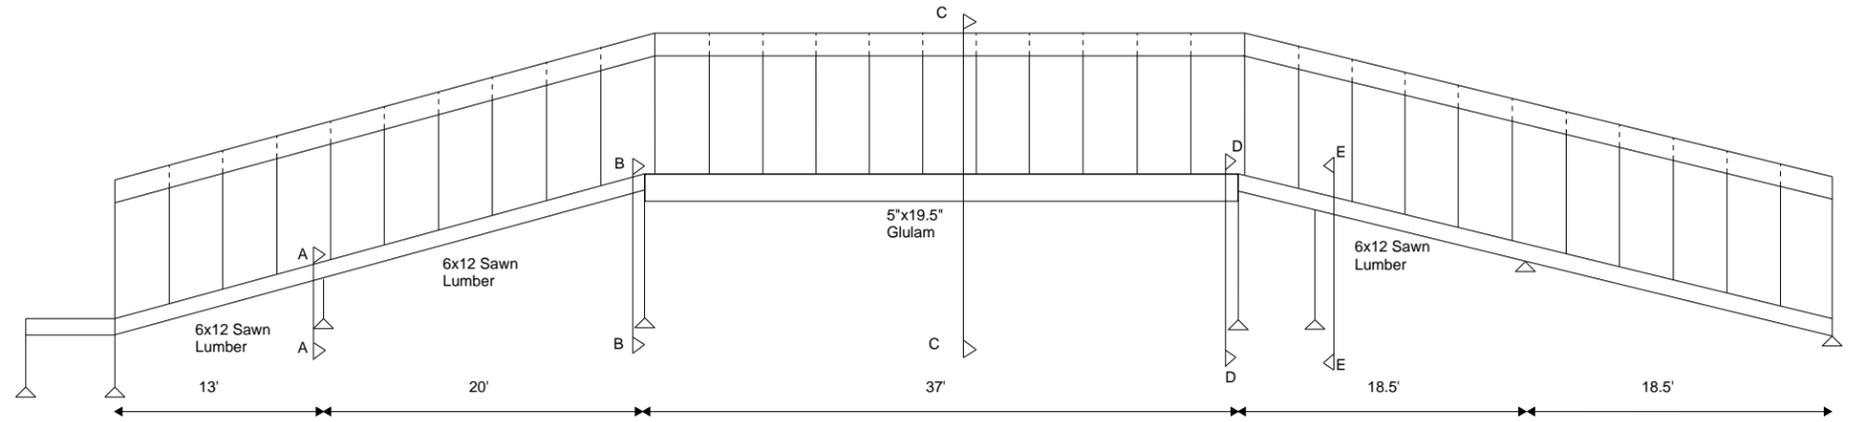
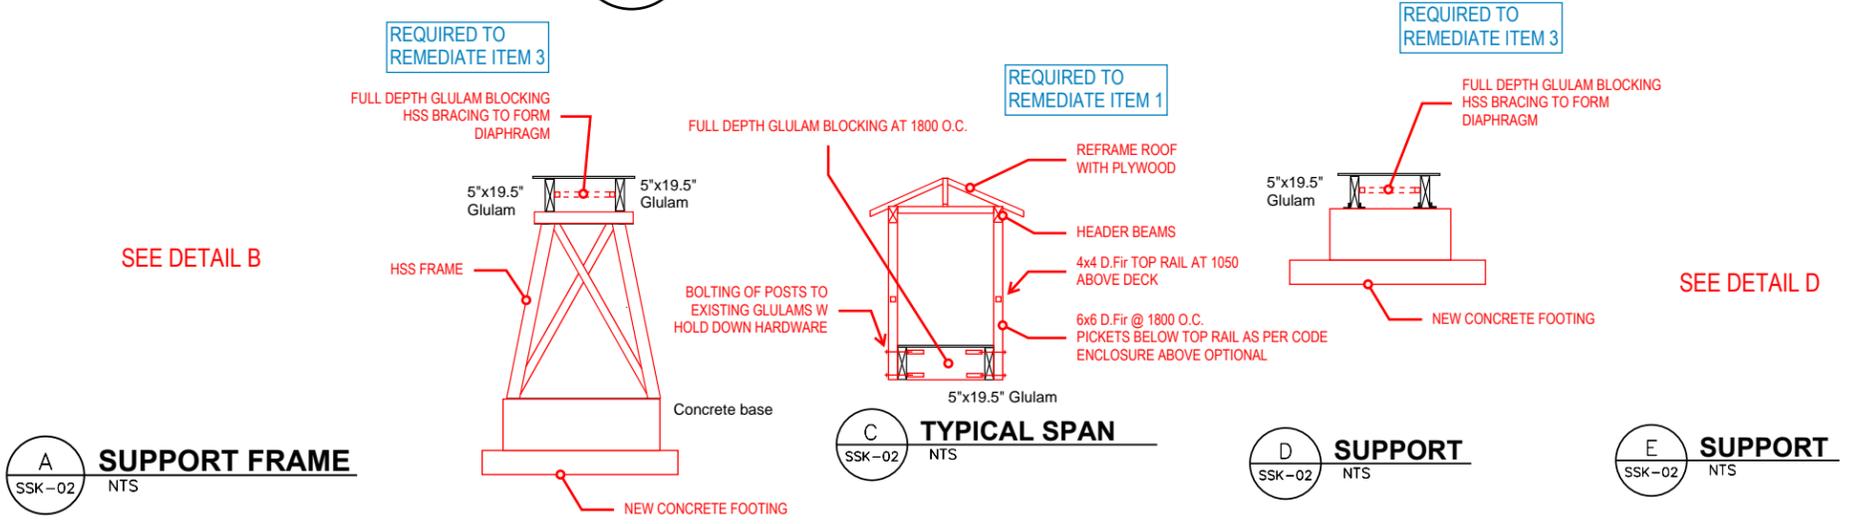
Sketch Title  
**RECOMMENDED UPGRADES**

1. UPGRADE THE SUPER STRUCTURE OF THE PRIMARY SPAN TO BE A FULLY CODE COMPLIANT GUARD RAIL SYSTEM.
2. REMEDIATE DETERIORATED ELEMENTS, PRIMARILY THE DECKING OF THE MAIN SPAN.
3. IMPROVE THE OVER SEISMIC SAFETY OF THE STRUCTURE.

- Install HSS diagonal bracing between the glulam beams below the decking to form a diaphragm
- Replace each pier with a purpose-built seismic frame of HSS steel sections. This would likely require new footings but could be done one frame at a time while shoring up the remaining bridge.
